### THE CHALLENGE

## QUADRAFIX

### THE PROCESS

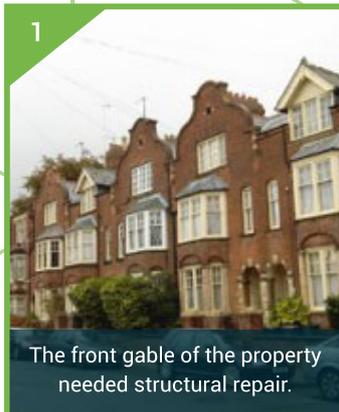
The Dutch gable of this three-storey property had considerable horizontal and vertical movement. It was found that the condition of the Dutch gable was poor and it was not tied back to the roof structure behind it.

1 The front gable of the property needed structural repair.
