### THE CHALLENGE

A brick building had a section on one corner which was moving and therefore causing cracking of the masonry. The main issues were:

### QUADRAFIX THE PROCESS

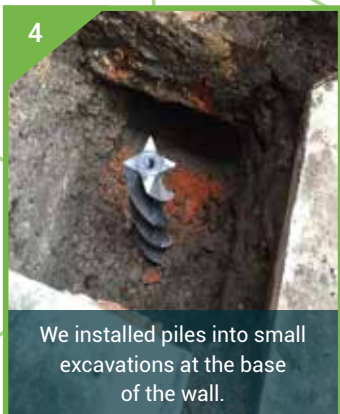
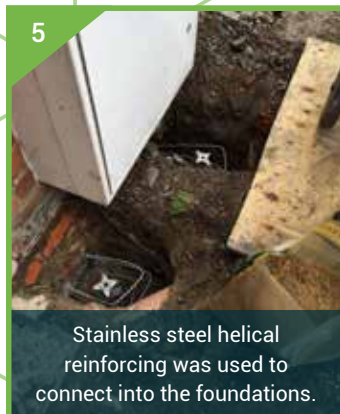
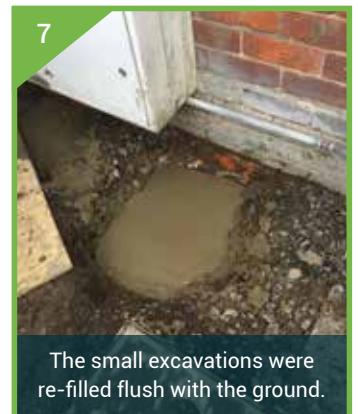
- Leaking drains causing wash-out from under and around the foundations.
- The gas supply to the building also entered at the affected area.

We designed a solution using masonry repair and QuadraPile underpinning.

Leaking drains were repaired and the gas main isolated before we installed bed joint reinforcement in the walls.

QuadraPile helical piles were installed in small excavations at

the base of the wall and were tied into the foundations using stainless steel helical bar and concrete pile caps. Once completed, the repair was almost invisible.
