THE CHALLENGE

To design and install a solution to stabilise the brickwork and lintels in two multi-storey blocks of flats, which posed the following challenge:

THE PROCESS

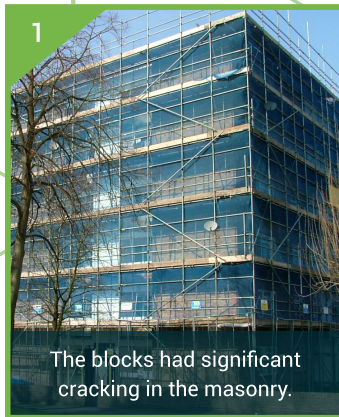
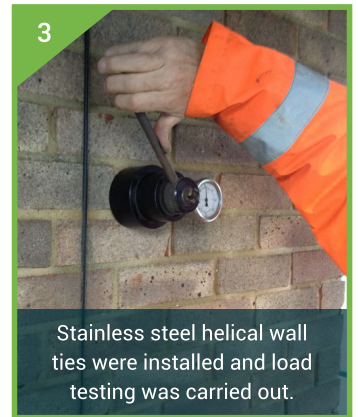
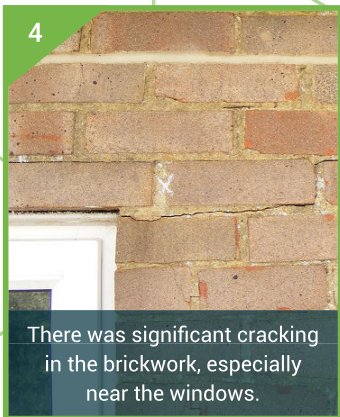
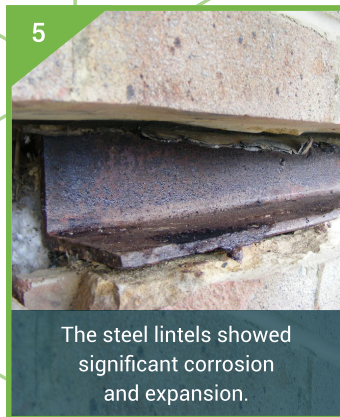
- The masonry and lintels above the windows had extensive cracking and corrosion due to thermal movement and weathering.

We installed stainless steel helical masonry reinforcement using our cementitious grout around the cementitious grout around the building. We then installed helical wall ties to reinstate the link between the outer brickwork and inner leaf.

The corroded lintels were locally exposed and treated with a high-performance rust inhibitor

before the brickwork was reinstated.

The masonry reinforcement ensured that the brickwork was held in place whilst the lintels were treated.
