### THE CHALLENGE

During an extensive refurbishment project, it was discovered that the service room at the top of a high-rise block of flats had unstable inner leaf masonry, due to lack of wall ties.

## QUADRAFIX THE PROCESS

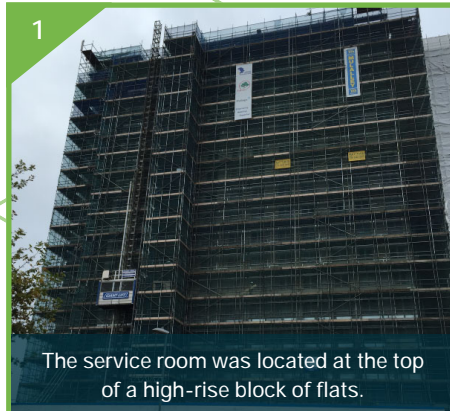
1 The service room was located at the top of a high-rise block of flats.

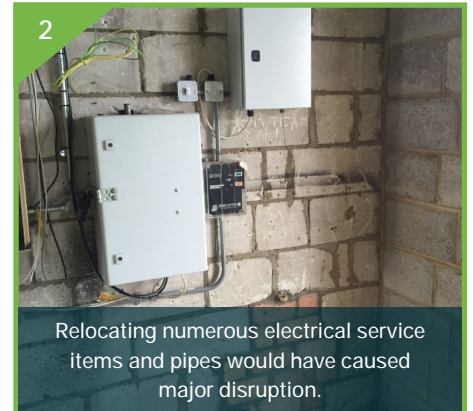
2 Relocating numerous electrical service items and pipes would have caused major disruption.

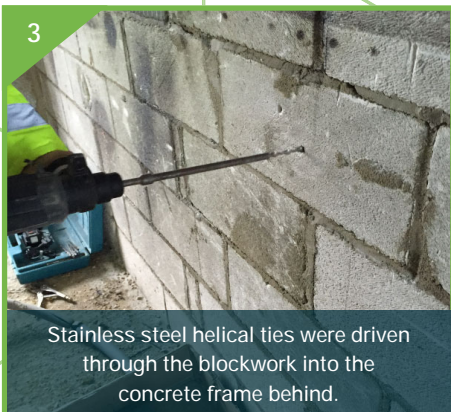
3 Stainless steel helical ties were driven through the blockwork into the concrete frame behind.

We installed stainless steel helical ties through the inner leaf and into the concrete frame outer leaf to restrain the masonry.

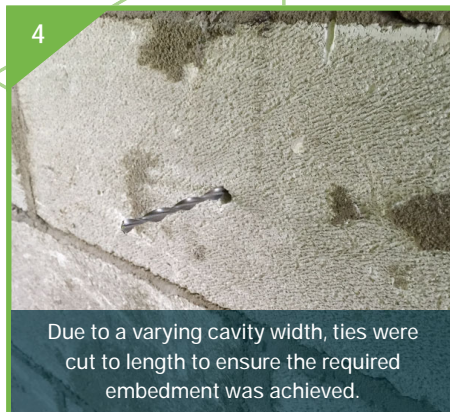
4 Due to a varying cavity width, ties were cut to length to ensure the required embedment was achieved.

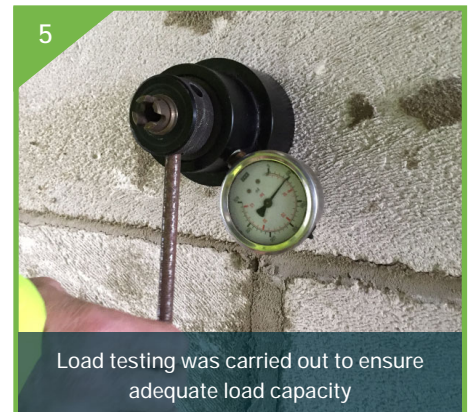
5 Load testing was carried out to ensure adequate load capacity

Trial tests were carried out to ensure adequate load capacity was achieved. All required
