THE CHALLENGE

A new external insulated render system was to be installed to increase the efficiency of the old university buildings.

QUADRAFIX

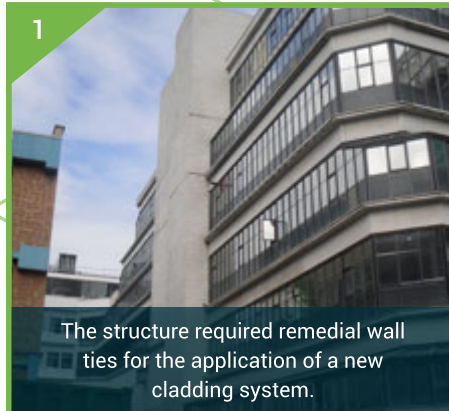
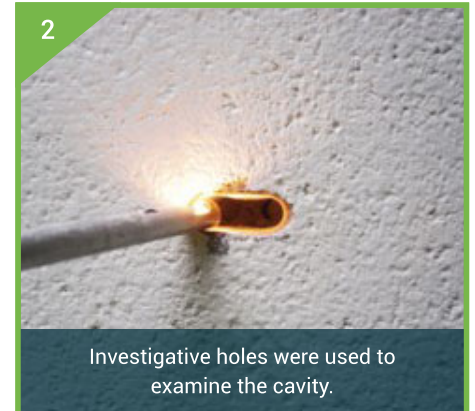
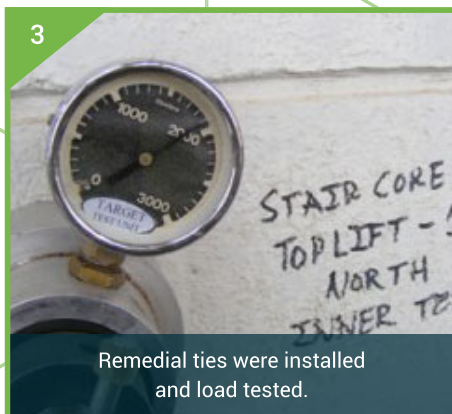
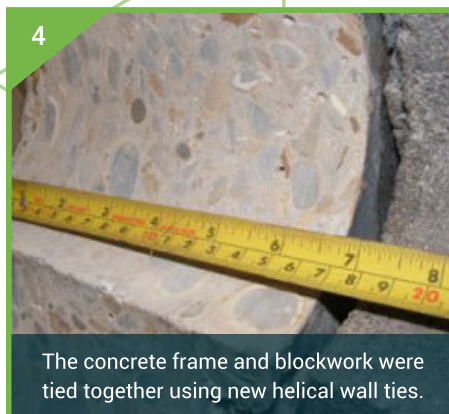
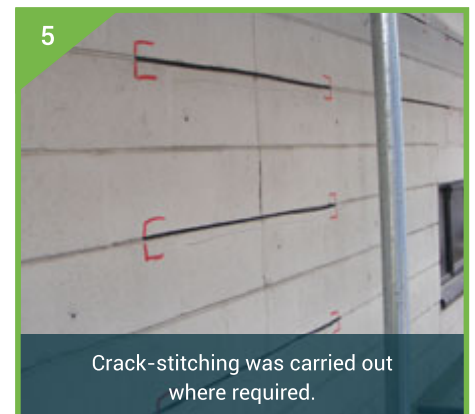
THE PROCESS

We installed several thousands of helical remedial wall ties and hundreds of helical bar crack stitches to secure the two leaf masonry and reintroduce

the structural integrity of the masonry via the crack stitches.
